## **Hizar Pin Gate 12-862251-000**

### **Installation**

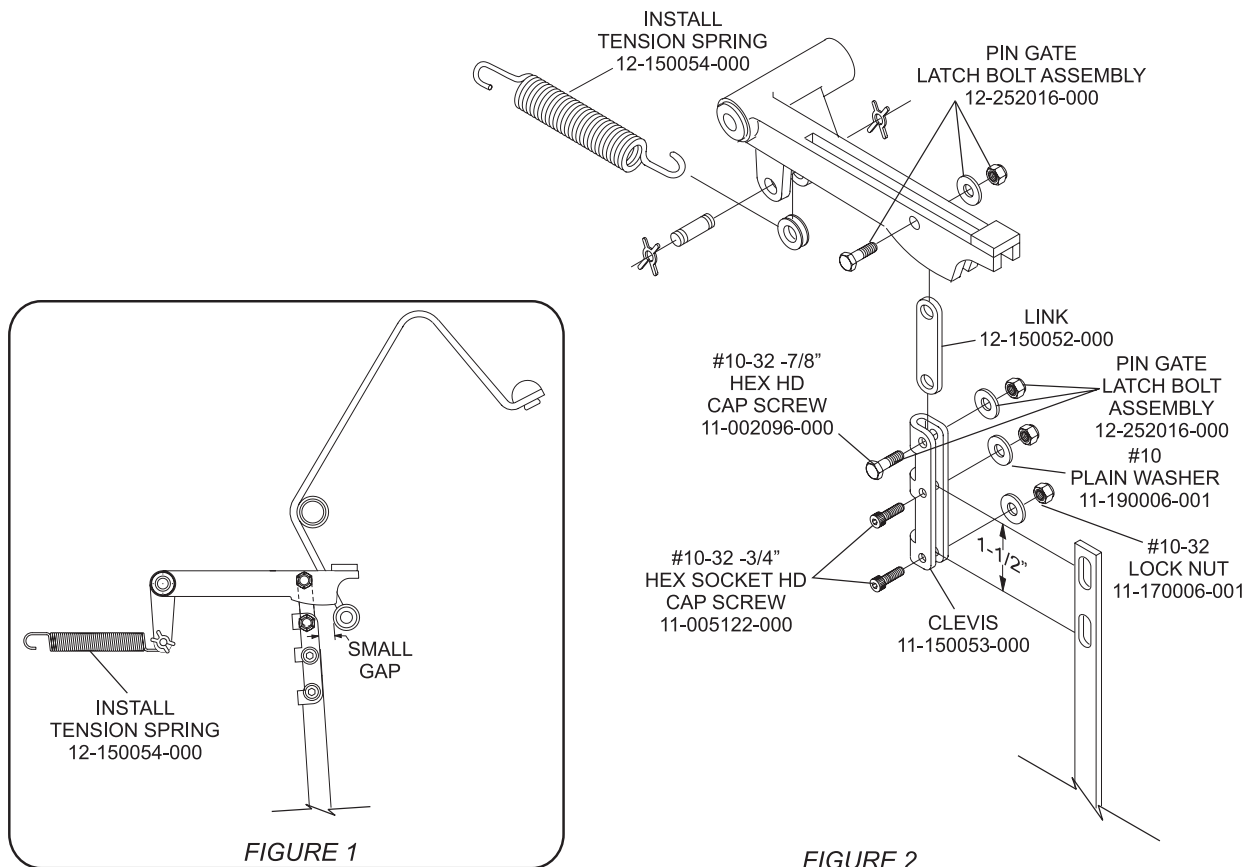
**i** **NOTE:** In this upright position there must be a small gap between the latch and the pin gate. Refer to Figure 1.

7. Insert the two bolts into the Hizar pin gate link, going through the slotted holes of the pin gate latch link. Place the washers on the bolts and thread the lock nuts in place.
8. Before the bolts are tightened, see that the pin gate latch link and the Hizar pin gate link form a straight line and that the pin gate latch is blocking the pin gate. Tighten the bolts making sure the clamping link of the Hizar pin gate link is clamped tight to the pin gate latch link.
